Intel[®] Mobile Celeron[™] Processor at 466 MHz, 433 MHz, 400 MHz, 366 MHz, 333 MHz, 300 MHz, and 266 MHz Specification Update

Release Date: November 2000

Order Number: 244444-020

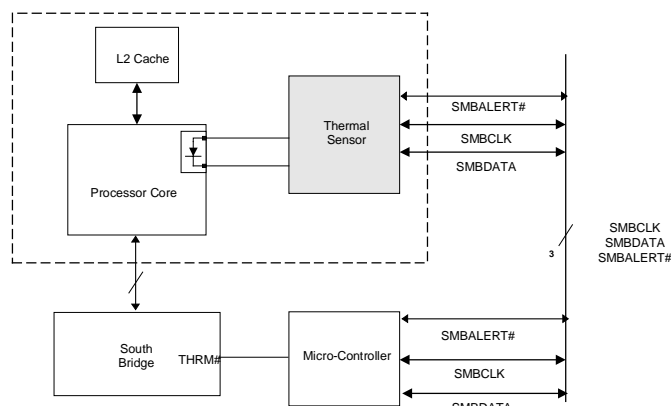
Figure 1. An Example of Microcontroller Driven Thermal Management

Problem: The Intel Celeron Processor Mobile Module has a thermal sensor that monitors the processor core's temperature. Please note that desktop systems could have a similar thermal device. The thermal sensor asserts SMBALERT# if the processor temperature exceeds the temperature limits set in the Alarm Threshold Registers (T_{HIGH} , T_{LOW}). It also sets the corresponding Status Register bits to identify the cause of the interrupt. Figure 1 gives one example of the how the SMBALERT# signal could be used in a system.

Implication: There is no system impact from this erratum if temperature polling is used for processor thermal management. If the SMBALERT# interrupt is employed to manage processor thermal sensing, then servicing the false interrupt may result in premature system action depending on the software and hardware implementations used. The rate of the false interrupts is less than the auto-convert rate of the thermal sensor.

Workaround: Three different (mutually exclusive) workarounds are possible:

1. Before servicing an interrupt from the thermal sensor, read and compare the processor thermal reading with the threshold limits (T_{HIGH} or T_{LOW}). Figures 2 and 3 provide basic flowcharts for the implementation of this workaround in an interrupt driven system.
2. If the firmware implemented polls the Status Register only, then before taking any action, re-read the temperature register and do a comparison with the alarm threshold limits (T_{HIGH} or T_{LOW}) to determine if the value is actually still within the temperature window.
3. Use a temperature polling scheme to monitor the processor temperature.
